FAILURES CAUSED BY ADDITIVES AND CONTAMINANTS DURING PROCESSING AND STORAGE

M. Ezrin and G. Lavigne
Institute of Materials Science, University of Connecticut
Storrs, CT 06269-3136

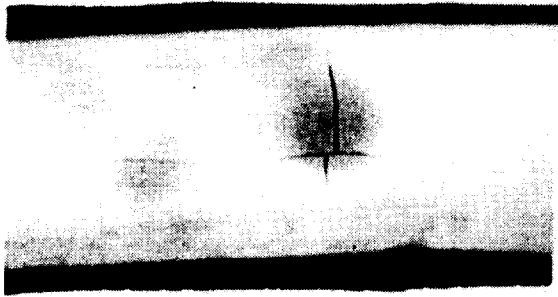
2.1.2 A similar cable formulation without Mylar was aged at 150°C in an air oven after processing to determine heat resistance. Surface brown spots formed which were brittle, i.e., cracked on flexing (figure 1). This effect was due to HBr evolved by flame retardant, which reacted with lead oxide and zinc oxide present. In the ionic state, lead, in particular, is a catalyst for oxidation of polyolefins. This experiment showed that HBr is evolved at low levels at 150°C, within the range used to crosslink cable polymers during processing (2.1.1 above).

Fig. 1. Cracks formed on flexing surface brown spot of EPR insulation containing brominated hydrocarbon flame retardant, resulting from oven aging at 150° C.

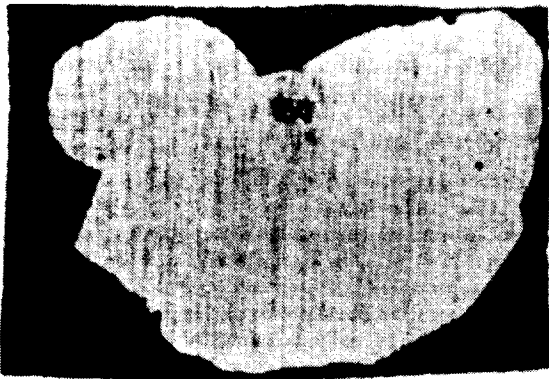
The surface of primer where topcoat had lost adhesion was examined by micro infrared spectroscopy, microscopy, and headspace GC/MS. By microscopy a locus of failure could be observed (figure 2, top center). In the original colored photo, a circular oil-like stain surrounds the locus. In some cases, a very fine lint fiber could be seen, and infrared gave a typical cellulose spectrum. In other cases, the locus of adhesive failure appeared to be a mechanical defect in the metal, such as a very small indentation. Generally, a tiny droplet of oily liquid could be seen (figure 3). In the colored original microphoto at 1000 X mag., well-defined colored interference fringes could be seen emanating from two black lines (the locus of adhesive failure). In the black and white photo of figure 3, the interference fringes are seen as alternate light and dark lines. This phenomenon is a well-known indication of a substance on a surface with variable film thickness.⁴ From the number of color fringes, the film thickness is estimated up to 1.5-2 microns. In the case of figures 2 and 3, there is no well-defined contaminant such as a fiber. It may have been removed along with the topcoat when it separated from the primer. Figure 3 also shows separate tiny globules of oil (lower right).

Fig. 2. Surface of primer coat on metal backing of cap liner, where topcoat was removed due to localized adhesive failure; locus of failure top center. Approx. 25X mag.

The solution to this problem seems to be to prevent mechanical damage and contamination of the surface between primer and topcoat by lint and other materials that reduce the strength of the adhesive bond. Presumably a coating, such as EVA (ethylene vinyl acetate), without a high content of plasticizer and other liquid components would be less likely to lose adhesion.

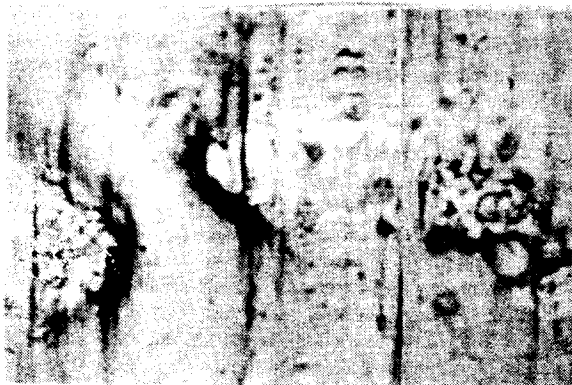
Fig. 3. Locus of failure of Fig. 2. Interference fringes of alternate dark and light lines due to liquid on the surface. Approx. 500X mag.

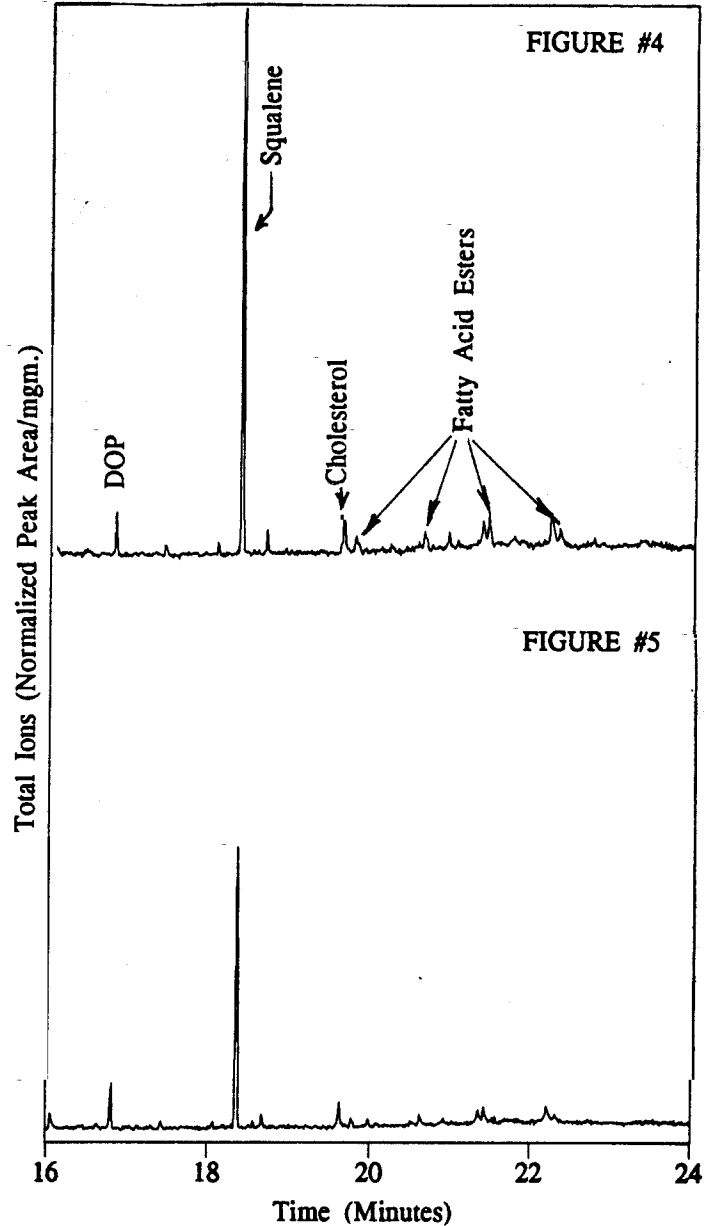
Figure 4 is a chromatogram for a combination of the metal, primer and the bare surface from which topcoat had been lost due to poor adhesion; figure 5 is the same for an area from which topcoat had been scraped as a control for figure 4. These chromatograms show significantly higher content in particular of squalene and fatty acid esters in the adhesive failure area. The source of squalene as well as cholesterol is unknown. However, the identification of squalene was confirmed by a reference mass spectrum and it was also possible by infrared spectroscopy to see sufficient characteristics of the infrared spectrum of squalene to help support squalene as the material. Squalene was also confirmed by the GC retention time with a reference sample. Cholesterol and fatty acid esters could be from epoxidized soybean oil believed to be a component of either or both of the primer and the topcoat. The identification by mass spectra of cholesterol and fatty acid esters, as well as of DOP plasticizer and squalene is certain. In other GC runs, another plasticizer from the vinyl topcoat was detected as dicyclohexyl phthalate. This is not seen as a separate peak in figures 4

and 5 because of the low content of the dicyclohexyl plasticizer.

Fig. 4. Portion of headspace GC/MS chromatogram of metal plus primer from which topcoat was lost due to adhesive failure (Fig. 2,3).
 Fig. 5. Control for Fig. 4 - metal plus primer from which topcoat was scraped off at a location with normal adhesion of topcoat to primer.

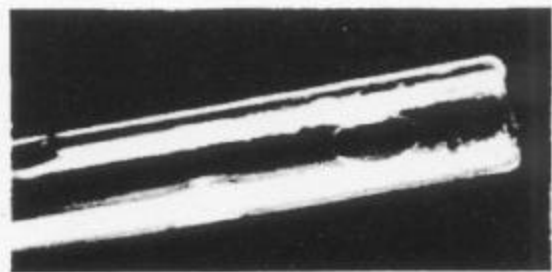
Fig. 7. Tubing of Fig. 6 with DOP drops (right) that exuded on inside surface due to pressure of the packaging in long-term storage.
