CASE STUDIES OF FAILURE OF POLYMERIC ELECTRICAL INSULATION

Myer Ezrin and Gary Lavigne

University of Connecticut, Institute of Materials Science

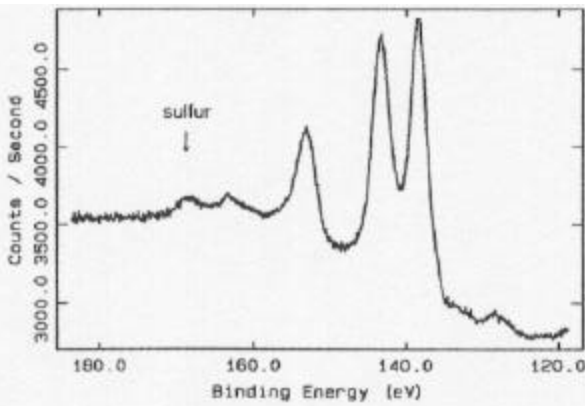
3.1.4 Colored jacket of cable was badly discolored as made in a very thin band of dark color at the outside surface. The cable was crosslinked with peroxide following extrusion under steam pressure in a continuous vulcanization (CV) line. Discoloration occurred only if the CV line was also

used for other cables which were sulfur cured. Hydrogen sulfide (H_2S) is a byproduct of sulfur curing. If the same recycled water for steam curing was used for cables with both types of cure, unacceptable discoloration of colored cable occurred. While H_2S was the likely cause of discoloration, manufacturing engineers had to be convinced because it meant either using separate CV lines or not using recycled water to prevent discoloration. In either case, manufacturing cost or scheduling was affected.

The thickness of the discoloration was of the order of a small fraction of a micron. Analysis to detect sulfur in the discolored surface by scanning electron microscopy/energy dispersive x-ray spectroscopy (SEM/EDX) [5] was not positive. The method analyzes 1-2 microns, so that sulfur content was below the detectability limit. In addition, lead and sulfur overlap in the spectrum, and a colorless lead compound was present in the jacket formulation. Another method of analysis was needed if proof of the presence of sulfur as the cause of discoloration was to be confirmed.

X-ray photoelectron spectroscopy (XPS) [6] was performed on discolored surface and on undiscolored material below the surface. XPS analyzes thicknesses up to about 50-100 angstroms (5-10 nanometers or 0.005-0.01 micron). Sulfur was detected at the surface and not below the surface. Because the discolored samples analyzed had been handled without protective gloves, it was possible that the sulfur was from body chemicals, or sulfur compound dried on the surface from the water used in steam curing. To eliminate such extraneous sources of sulfur, the surface was washed with soap and distilled water and rinsed thoroughly with distilled water. Sulfur was still detected at the surface, confirming its role in discoloration. The color change is believed to have been caused by reaction with the colorless lead compound to form lead sulfide, a black compound. Figure 1 is the XPS spectrum showing the sulfur 2p peak at 168.75 electron volts (ev) binding energy [7]. The two largest peaks are lead and the medium size peak at 153.12 ev is silicon.

Figure 1. X-ray photoelectron spectrum of discolored surface of cable jacket. The peak with the arrow is the sulfur 2p peak, which is absent below the surface.

A change in formulation might prevent discoloration. If that is not possible, then either a separate CV line is needed or scheduling so that the colored cable is not exposed to H_2S during steam curing.

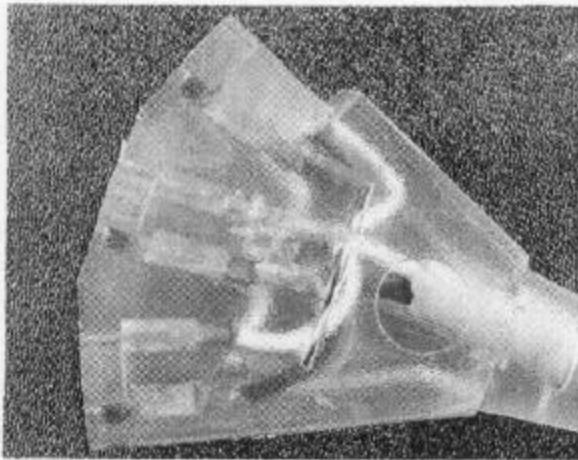
4.4 Failure due to corrosion of brass contacts occurred in an extension cord with a three pronged plug at one end. One inch thick clear thermoplastic insulation was over the set of three plugs. In service the brass contacts turned green, readily seen through the clear plastic, which was a copolymer of vinyl chloride and vinyl acetate. Analysis of the green corrosion by thermal desorption gas chromatography/mass spectroscopy (TD/GC/MS) [11,12] gave acetic acid and formic acid. The concentration of the acids was much less in the plastic away from the contacts. Figure 2 shows the plastic over the set of three plugs. Figure 3 is a sketch of a closeup of one contact with the green corroded area outlined dark. The acids probably formed in molding the thick copolymer over the contacts. High temperature would be needed to thoroughly fuse such a thick part. Copolymers with vinyl acetate split out acetic acid quantitatively at about 300°C, and slowly at lower temperatures [13]. Organic acid formed during molding will react with brass to give green copper salt. Performance may not be affected adversely but the corroded appearance is undesirable. It may be possible to prevent such problems caused by acid with acid scavenger type stabilizers.

Figure 2. Transparent encapsulant on a three plug extension cord. Brass contacts have green corrosion (not visible in the figure).

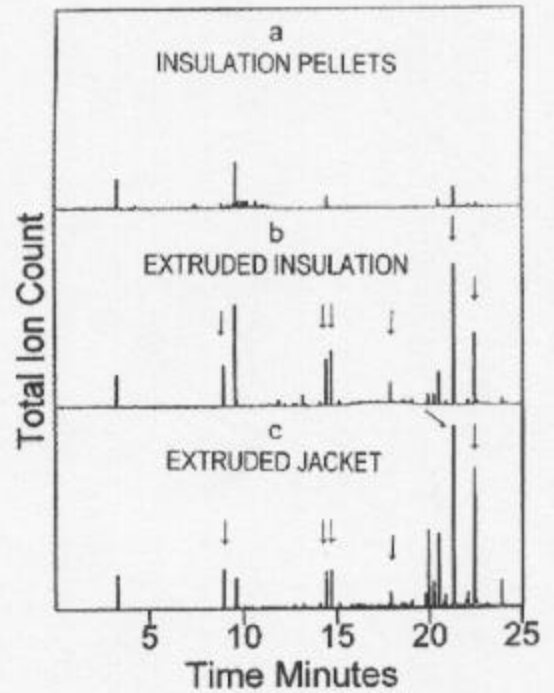
4.5 Low insulation resistance (IR) developed in service with low voltage single conductor cable, approximate thickness 3-5 mm. The cable consisted of plasticized PVC insulation and a different formulation PVC jacket. Insulation resistance fell to an unacceptable level in service. Analysis by TD/GC/MS showed that substantial transfer of additives occurred from jacket into insulation, causing insulation

resistance to fall. The jacket formulation was not designed for high insulation resistance, so that migration of additives into insulation caused resistance to fall. Figure 4 gives the chromatograms of (a) unmolded insulation pellets, (b) insulation with low IR, and (c) jacket. In the b and c chromatograms, arrows point to peaks in the insulation that transferred from jacket. Formulation changes or a barrier layer are needed to prevent this problem.

Figure 4. Thermal desorption gas chromatography/mass spectroscopy of cable that developed low insulation resistance in service; (a) insulation pellets before extrusion, (b) extruded insulation following some time in service, (c) extruded jacket; arrows indicate the compounds that migrated from jacket to insulation.

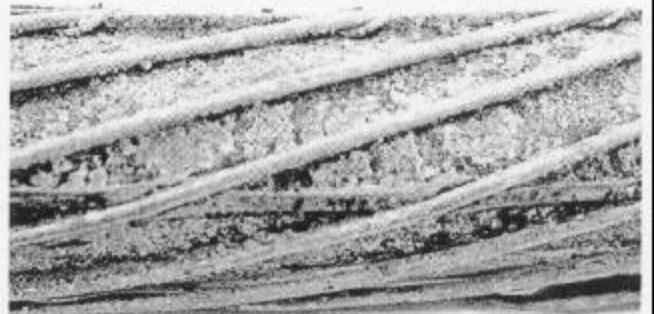
4.6 Failure of unjacketed shielded underground polyethylene power distribution cable occurred in cold northern climate [14] with mineral rich soil. The failed cables have shield wires with heavy mineral encrustment of high calcium carbonate content (Figure 5). With the cable and shield wires dry, the resistance between the shield wires and the semiconductor layer over the insulation can be very high, approximately 50,000 ohms. The semicon layer itself had low resistance, as it should, so that the high resistance was not due to the semicon but to the fact that the shield wires lost their conductive connection to the semicon.

The first failures occurred 5-10 years after installation. Most of the failures occur in the spring, with 45% of the failures in May and 75% of the failures between May and August. This period corresponds to thawing and drying of the soil, along with lightning. The mechanism of failure appears to be that encrustment of the neutral wires causes separation and insulation of the neutral wires from the ground semicon over an appreciable distance. Lightning strikes or switching surges can cause a large potential difference between the conductor below the insulation and shield wires. Normally, the shield wires and ground semicon would be in contact and at the same potential. The earth conductivity is normally quite high and would act to ground the shield semicon with or without the shield wires. However, when the ground is frozen and the shield wires are separated from the ground semicon by encrustment, both the earth and the encrustment have low electrical conductivity.

Switching or lightning induced overvoltages would cause the potential difference between the ground strand and the ground semicon to rise to the point that the gap between the ground strand and the cable semicon breaks down, resulting occasionally in sufficient energy to puncture the insulation and more often in enough energy to puncture the semicon but not entirely puncture the insulation. When the ground thaws in the spring, failures occur as the insulation becomes saturated with liquid water and the insulation breakdown voltage drops in punctured locations. This accounts for the rash of May failures. The late summer failures are probably the result of lightning activity in conjunction with partly punctured cable. Thus the damage occurs mainly during the winter as high soil electrical resistivity is required, but the failures occur predominantly

during the spring thaw. This failure mechanism requires two conditions: (1) encrustment of the ground shield wires and electrical separation of those wires from the semicon over a significant distance; (2) a very high soil electrical resistivity so that the ground semicon is not effectively grounded by the soil electrical conductivity or the ground shield wires. This occurs in frozen soil. The combination of high moisture, high calcium carbonate environment in a very cold climate provides the conditions for the failure mechanism.

Figure 5. Unjacketed power distribution cable with outer shield wires encrusted with dried soil, causing the space between the shield wires and the semiconductor outer layer of the cable to have high resistance. Reproduced with permission from figure 8 of paper by S. Boggs (ref. 14).

The obvious lesson to be derived from these failures is to use jacketed cable so that the conditions that develop in the absence of a jacket do not occur. The use of unjacketed cable was mainly to lower cost, which turned out to be counter productive in the very cold climate with high calcium carbonate soil.
