UNEXPECTED AND UNUSUAL FAILURES OF POLYMERIC MATERIALS

*Myer Ezrin and Gary Lavigne
Institute of Materials Science
University of Connecticut
Storrs, Connecticut 06269-3136*

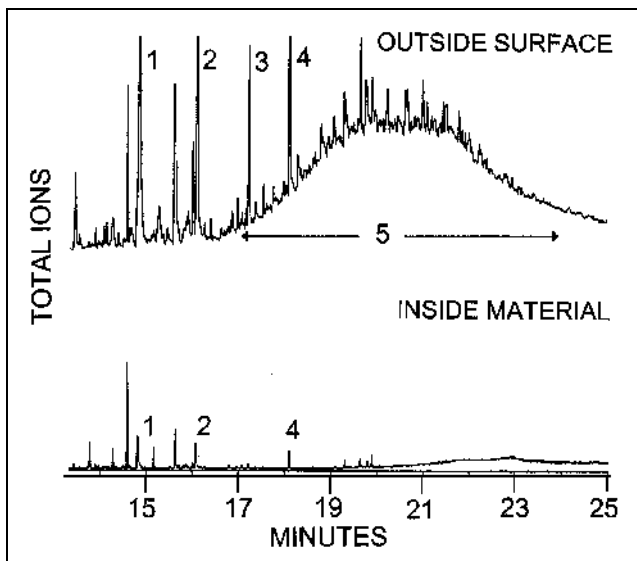
In the assembly of a clothes iron a two-part silicone adhesive was used to bond a molded phenolic resin base part to a polypropylene top part. Failure to bond to the phenolic resin portion was experienced. These parts had been stored on the plant floor uncovered for long periods of weeks and months before being assembled. Analysis of the surface of the phenolic parts revealed a high content of hydrocarbons (Fig. 1) that were not present below the surface. The hydrocarbons had been absorbed from the plant air, from sources such as the exhaust of material handling equipment, as well as from environmental air, which contains hydrocarbons from vehicle emissions and other sources. The hydrocarbons on the surface were a contaminant preventing adhesion to silicone adhesive.

Figure 1. GC/MS chromatogram of outside surface (top) and material below the surface (bottom) of phenolic resin part that could not be bonded to silicone adhesive; peak 1-hexadecanoic acid, 2-octadecanoic acid, 3-octadecanamide, 4-dioctylphthalate, 5-hydrocarbons (Ref. 5. Fig. 7).

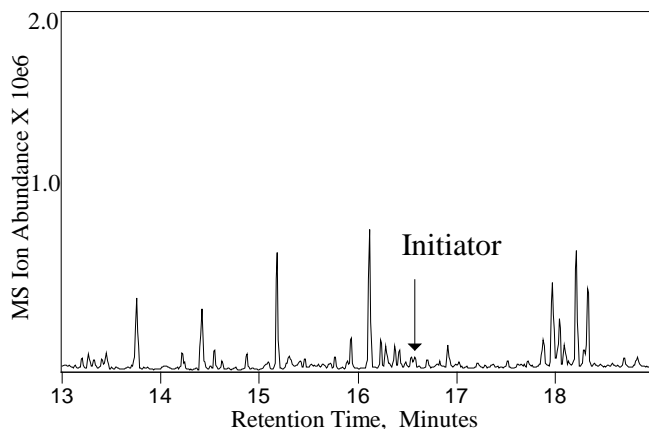
the bond is to be made and to be present at the required level. Sometimes the bond, such as metal to metal, fails. Thermal desorption GC/MS can detect initiator in a virtual "needle in a haystack" situation. In some cases it was absent or present at a very low level so that the adhesive did not develop its intended bond strength.

The analysis for initiator was done by scraping the surface of unbonded metal, providing 0.1-0.2 mg. sample. Using the University of Connecticut direct dynamic thermal desorption device, the sample was heated at 250°C/2 minutes. The volatiles thus generated were carried onto the head of the cryofocused GC column. Programmed heating at 15°C/minute produced the chromatogram of Figure 2. The initiator peak is indicated as a very small peak at a certain retention time (X axis). Figure 3 shows the mass spectrum of the peak for the initiator. Using single ion monitoring Figure 4 is the chromatogram only for mass 212 species, the major peak of the initiator. In this way initiator is detected at low levels. In the case shown initiator was present. In others none was detected and was responsible for adhesive failure of the metal to metal bond. In spite of the very small peak for initiator, the resolution and sensitivity of the analytical system make it possible to make positive identification of a compound present at very low level.

Figure 2. Thermal desorption GC/MS of metal surface to detect initiator in an adhesive (Ref. 7, Fig. 1).

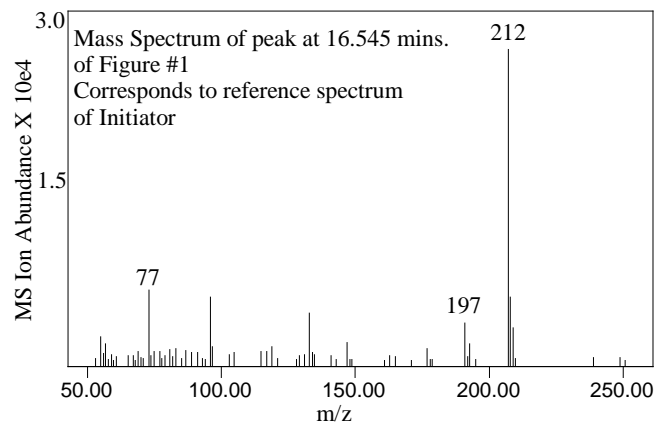
Figure 3. Mass spectrum of GC peak to identify initiator in Figure 2 (Ref. 7, Fig. 2a).

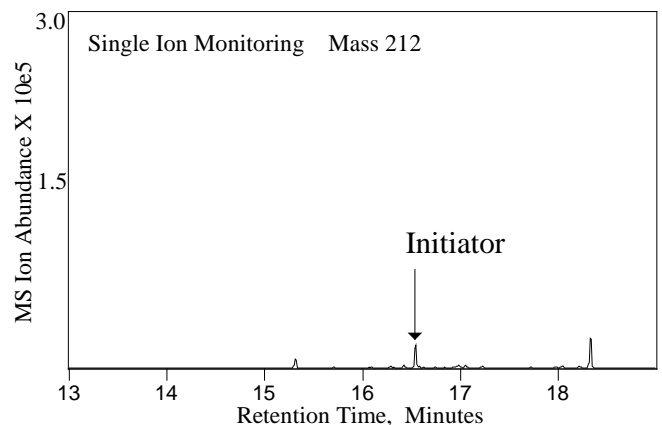
Figure 4. GC/MS of Figure 1 with single ion monitoring of ion mass 212 (Ref. 7, Fig. 2b).

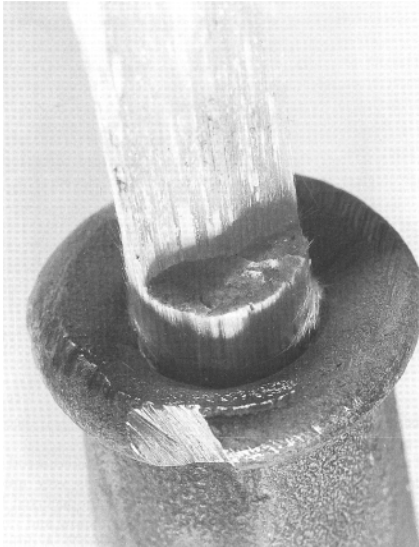
The rods are called guy strain insulator rods. They attach to a point near the power line at an angle. The other end goes into the ground. They provide non-conductive support for the power line. They are attached top and bottom to metal end fittings. Fracture of the rod occurred after several years of service a few inches above the lower metal end fitting.

A contribution to the problem was service condition, namely water from normal precipitation of rain and snow. An additional factor was their slightly acidic nature. Another major factor was the design of the galvanized metal end fitting (Fig. 5). The top part is shaped like a cup so that it holds liquid. The rod and end fitting are at an angle to the support post so that liquid entering the upper cup-like portion of the end fitting ran off the lower side of the end fitting. But some liquid would always remain there and evaporate to dryness. Solid matter that came with rain and snow would accumulate in the end fitting over time. Its nature was evident from the rust streak on the runoff side of the end fitting. SEM-EDX (scanning electron microscopy/energy dispersive x-ray spectroscopy) elemental analysis of the rusted streak and of the normal galvanized surface showed that the galvanizing elements were practically gone and sulfur was present. The sulfur was not present in the normal surface. It appears that acidity accompanied the rain and snow, admittedly at low concentration each individual time. However, over many years, of the order of 10-15, the accumulated acidity in the cup-like portion of the end fitting was sufficient to corrode the galvanized surface of the end fitting during the runoff.

But how does the cup-like design of the end fitting contribute to fracture of the rod? Polyester is susceptible to hydrolysis and resultant reduction of molecular weight. But the greatest weakness is the long strands of E glass fiber, which has poor resistance to water and even poorer resistance to acid. As the acidity of the solid deposit that accumulated in the lower side of the cup-like top of the end fitting increased, the pH of water that came with succeed-

ing deposits of rain or snow became lower and lower, i.e., more acid. That led to fracture of E glass fiber, which was a major component of the polyester rod. After a time, as more and more glass fiber fractured, the rod including polyester fractured.

In addition to design (of the top part of the end fitting) and the low resistance of E glass to water and acid, a third factor is stress, which can come from differences in coefficient of thermal expansion of glass and polymer vs. metal as temperature ranges from very cold to hot. Also stress caused by wind and by installation stress.

Because of reluctance by some people to believe that the failure was due to "acid rain," a study was conducted of the effect of stress, air, water and acidity. Rods were stressed by bending over a curved metal part and held down at the ends. In the central stressed area liquid was applied in a flexible plastic holder that surrounded the rod. The time to fracture was recorded. Clearly the rod is susceptible to water and stress, but much more so for acid and stress. The effect is an example of failure due to two stresses acting synergistically and simultaneously, i.e., mechanical stress and acid.

Figure 5. Polyester-fiberglass guy strain insulator rod fractured in electric transmission service (mechanical support rod) after 10-12 years. Note cup-like feature at the top of the end fitting where liquid is held and evaporated (Ref. 1, p. 178, Fig. 6-18).

Possible solution to prevent failure is to modify the end fitting to eliminate the open cup-like feature so that liquid does not evaporate and concentrate there. Another is to have a redundant rod, i.e., a second one so that if one fails, the other will hold the load.

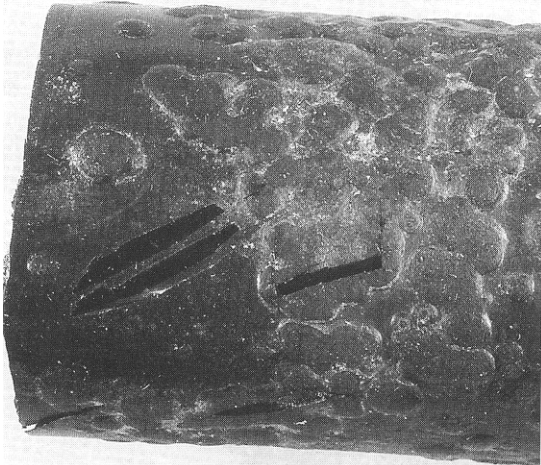
The next case exemplifies well the completely unexpected nature of some service conditions and the resultant failure that can occur. In Figure 6, a neoprene rubber jacket for electrical cable blistered in service. In the photograph there are blistered and unblistered areas. Cuts in both were made for analysis. The question to be answered was if the blisters were due to the jacket, or to an external service condition. In one case, the manufacturer of the cable system would be liable for damages, and in the other, the user is responsible. The cable was laid on the ground in a field to operate a radar antenna. The field was used to grow corn, for which spraying was done. The cable to the radar antenna ran through the planted area. It was suspected that the blistering was due to sprayed chemicals falling on the jacket. This was confirmed by gas chromatography/mass spectroscopy of volatiles which showed the presence of at least five compounds in blisters not present otherwise. This is a service condition far beyond anything reasonable to expect. The manufacturer of the cable did not know that it would be installed in a cornfield, and so had no reason to anticipate a problem from agricultural chemicals. Possibly if the manufacturer knew that, a more chemically-resistant jacket might have been used. The jacket was not fractured, and the cable functioned satisfactorily. Nevertheless, an obviously unusual appearance is unsettling to the user of the product.

Figure 6. Neoprene rubber jacket blistered due to agricultural chemicals sprayed on it in a corn field where neoprene jacketed cable lay on the ground for a radar antenna (Ref. 1, p. 177, Fig. 6-17).

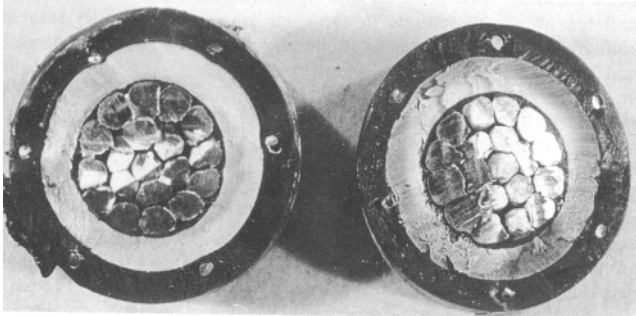
Electrical cable, rated for ca. 4000 volts, used to operate water pumps in a power plant failed due to overheating and embrittlement. Since there was no reason to believe overheating resulted from high current carried by the conductor, the cause of failure was not immediately obvious. The insulation was EPR (ethylene propylene rubber) and the jacket was chlorinated polyethylene. Embedded in the jacket were copper shield wires. A cross-section of unfailed normal cable is in the left of Figure 7. That for failed cable is on the right, the insulation being darkest next to the jacket. Had the overheating started from the main conductor, the darkening of EPR insulation would have been greater starting at the conductor. But the reverse was true, suggesting that the source of heat was in the jacket. It was found that the shield wires carried 25 amperes, an abnormally high unintended current. Being embedded, the heat was not readily carried off and the jacket became overheated. The dark color the EPR took on was due, at least in

part, to HCl (hydrogen chloride) gas evolved by chlorinated polyethylene at high temperature. Another indication of evolution of HCl by chlorinated PE is that the wires were green, due to reaction with HCl. The importance of these observations was that they proved the source of excessive heat was in the jacket, not the main conductor. Then, probing what may have caused that, the root cause of the problem was discovered as high shield current

Figure 7. Cross-section of degraded (right) and undegraded cable showing darkening of insulation started near the outer part of the cable where the ground wires are located in the black jacket (Ref. 1, p. 163, Fig. 6-5).

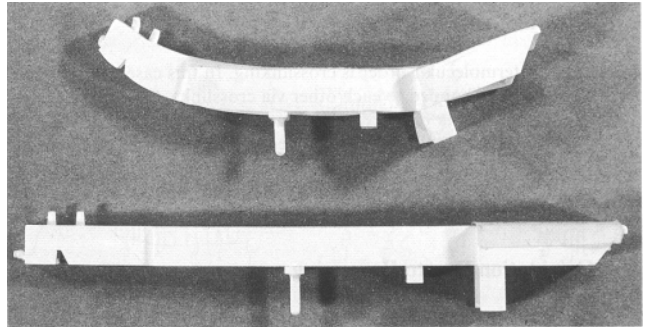
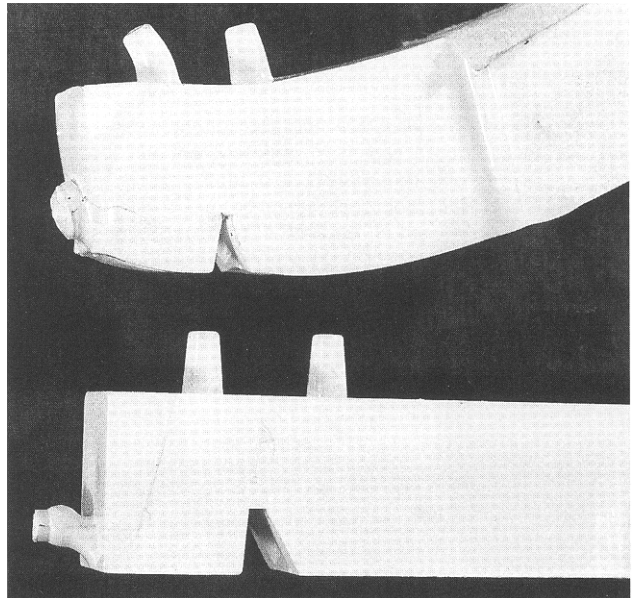
An injection molded SAN (styrene-acrylonitrile) piano key had a hook end that attached to a metal spring to make the key spring back after being played. The hook end experienced fracture (Fig. 8, 9). Fracture occurred when the inside of the piano was cleaned with ketone solvent to remove adhesive from areas where it was not needed. The solvent vapor condensed on the piano keys causing fracture at the hook end spring location. The cause was sought by performing thermal reversion to observe the level of frozen-in or internal stress due to injection molding. Heating is done several degrees above the glass transition temperature for a short time. The part shrinks and distorts in response to the frozen-in stress. Parts with low internal stress will not shrink and distort much. The photos show extensive shrinking. Of particular importance is the shrinkage of the hook end (Fig. 9), which is greater than shrinkage of the whole part. It was concluded that fracture was due to condensed solvent acting as an environmental agent at a high stress point, the hook end. The stress may have come in part from the external spring tension as well as internal frozen-in stress.

Figure 8. SAN piano key before and after (top) heating to release frozen-in stress (Ref. 1, p. 42, Fig. 2-20).

Figure 9. Close-up of hook end (left) on SAN piano key before and after (top) heat shrinkage (Ref. 1, p. 43, Fig. 2-20a).
