# FAILURE ANALYSIS OF RUBBER PROTECTIVE GLOVES

*F. Leek\*<sup>1</sup>, G.Lavigne<sup>1</sup>, L.Pinatti<sup>1</sup>, R.Ristau<sup>1</sup> and R.Raymond<sup>2</sup>*  
*<sup>1</sup>Institute of Materials Science, University of Connecticut, Storrs, CT*  
*<sup>2</sup>Northeast Utilities Service Company, Hartford, CT*

## Abstract

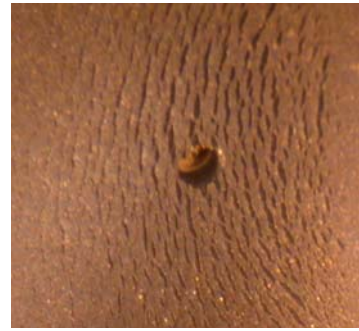
Optical and SEM images of this damage can be found in Figures 4 & 5. The SEM images show inter-particle fracture. Cross-sectioning shows these fractures occasionally penetrate to significant depths (~150um). None penetrated into the yellow rubber layer below.

Occasionally cylindrical holes were found associated with the crazing damage (Figure 5). SEM images (Figure 13) show the pinhole (~450um diameter) is surrounded by splay. This damage results from discharge during the in-house tank testing used to validate glove integrity. Its association with regions of crazing confirms the latter's negative impact on glove integrity with regards to electrical insulation.

**Figure 4:** Optical microscopy image of "crazing" damage and perforation hole in black rubber outer surface.

When wearing the current leather protective glove over the rubber glove, it was noted that bulky seams in the former create distinct high points at the very locations of the observed crazing. These seam “bumps” would be forced into the rubber glove whenever the line mechanic grapples with the high voltage conductor. Subsequent lateral movement during gripping would result in creasing and micro tears in the observed configuration. The seam configuration in the secondary supplier is completely different and does not exhibit bulk in these areas. This explains the apparent elimination of this damage by switching leather glove suppliers.

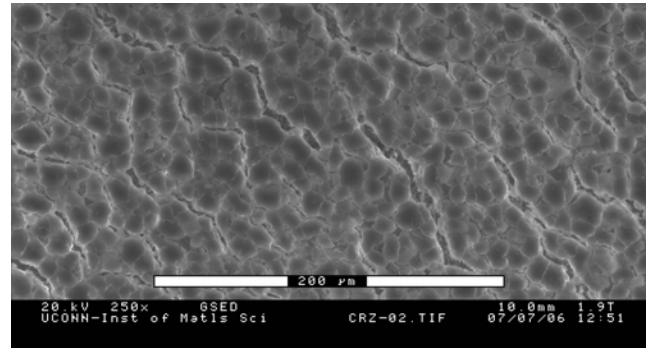
This damaged has been referred to as "crazing" because it visually resembles crazing in other polymers such as polymethyl methacrylate and polycarbonate. Crazing typically results from chemical incompatibility and is not common in rubber products. Cracking is reported and typically results from either mechanical fatigue or chemical attack.

Mechanical fatigue of rubber results in cracks which nucleate and grows from pre-existing flaws such as filler agglomerates, impurities, nonuniformity (i.e. additives, crosslinking) or imperfections in mold surfaces. To determine if mechanical fatigue was a possible root cause here, a section of rubber (~4"x~2") was removed from a new glove cuff. This section was wrapped

around the section of high voltage cable provided such that the black rubber surface was in direct contact with the cable. The section was grasped firmly then twisted back and forth several times in an attempt to mimic in-use handling. Visual inspection showed this resulted in a series of relatively parallel micro-creases similar in organization to the observed “crazing”. SEM confirmed these are accompanied by small inter-particle tears. This would seem to suggest that mechanical fatigue is a likely source for the observed “crazing”.

**Figure 5:** Higher magnification image of crazed surface. (SEM)

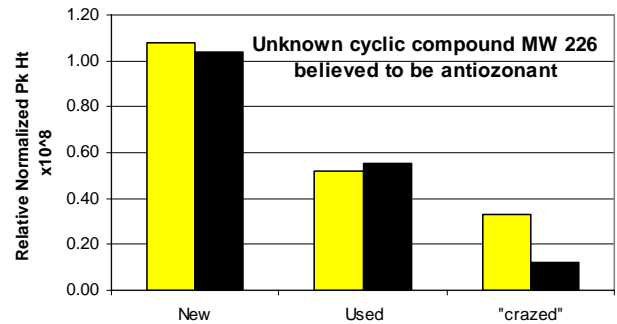
- 2) TD-GC/MS of black and yellow rubber from new, used and crazed regions show a prominent drop in the concentration of the unknown cyclic compound suspected to be an antiozonant (Figure 6). This suggests that the glove is exposed to significant ozone in use and that the antiozonant is being consumed, as is expected, to form a protective layer. The concentration is extremely low in the “crazed” surface thus suggesting future protection against ozone attack may soon be compromised.

**Figure 6:** Change in level of suspected antioxidant with use (TD-GC/MS).

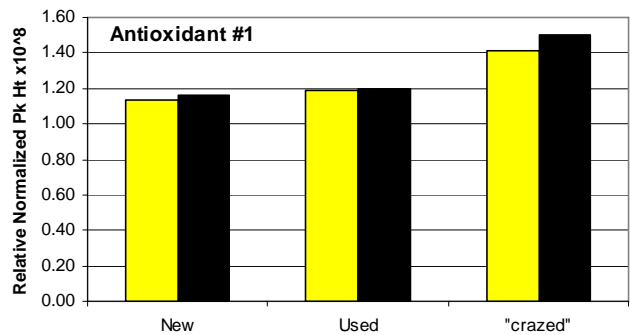
Similar trending of the antioxidant shows its level increases in the damaged region (Figure 7). The antioxidant is also expected to migrate from the bulk to the surface to provide the necessary protection. The increased surface area in the “crazed” region may be responsible for the observed trend. This result suggests oxidation damage maybe of lesser concern.

**Figure 7:** Change in level of antioxidant with use. (TD-GC/MS)

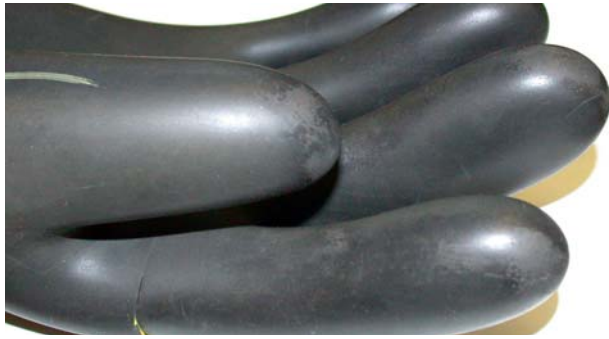
Several of the gloves exhibited pronounced dullness at the finger tips and along the backs of the fingers (Figure 8). In many cases, this dullness was surrounded by dark, shiny areas. SEM images (Figure 9) show this corresponds with texturally rough areas surrounded by relatively large, smooth surfaced “islands”. It was proposed that this may result from erosion/vaporization in the dull regions accompanied by either re-deposition of low molecular weight material or melting and coalescence of granules in surrounding areas. Corona damage was suspected.

**Figure 8:** Image showing dullness at the fingertips of a used rubber glove.

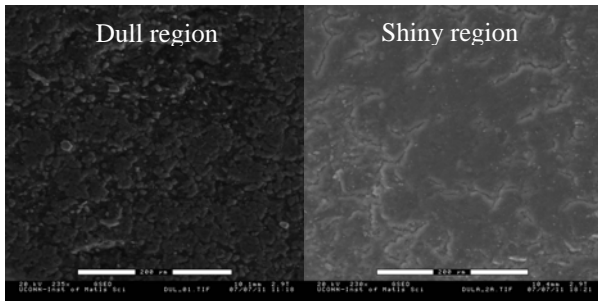
**Figure 9:** Higher magnification (SEM) images of dull and surrounding shiny regions shown in above image.

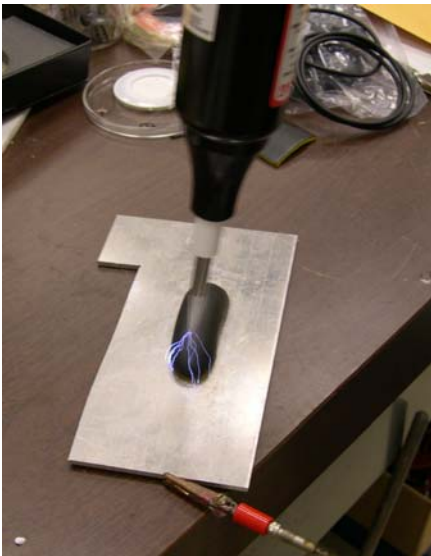
To confirm, a section from a rubber glove was placed on a grounded piece of aluminum and exposed to the direct discharge of a tesla coil (Figure 10). After approximately 5 minutes, a small dull region surrounded by a dark, shiny region was seen. The induced damage was visually identical to that seen on the used gloves.

**Figure 10:** Inducing corona damage in the lab via tesla coil.

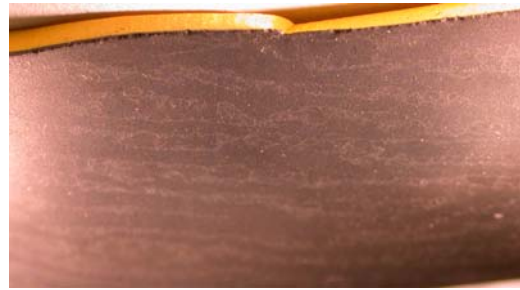
Several of the gloves exhibited pronounced surface streaks running down the cuff (Figure 11). Their appearance and configuration is suggestive of draining fluid, perhaps after wet cleaning. SEM images of these same areas (Figure 12) show localized loss of surface granules in a linear pattern. Subsequent discussion revealed that this streaking is often visible on brand new gloves and thus must result from variation within the manufacturing process.

**Figure 11:** Image showing streaking down cuff.

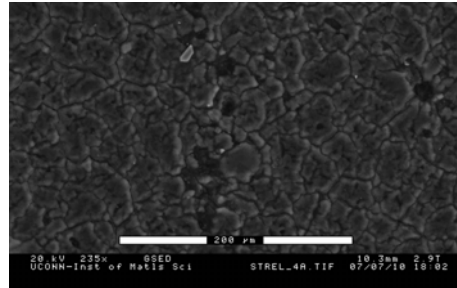
**Figure 12:** Higher magnification (SEM) images of streaking shown in above image.

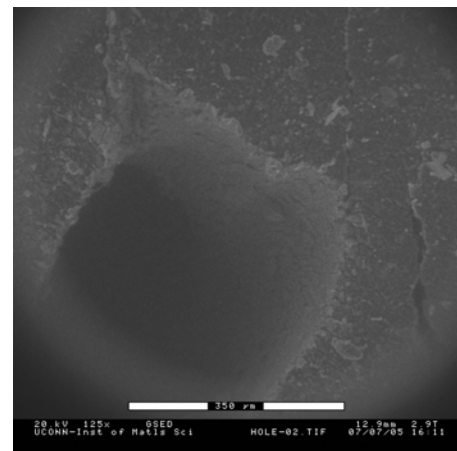
**Figure 13:** Higher magnification (SEM) images of pinhole similar to the one shown in Figure 4.
