# FAILURES DUE TO COMPOSITIONAL FACTORS

*Myer Ezrin, Gary Lavigne, Institute of Materials Science,  
University of Connecticut, Storrs, CT*

## 1.0 Abstract

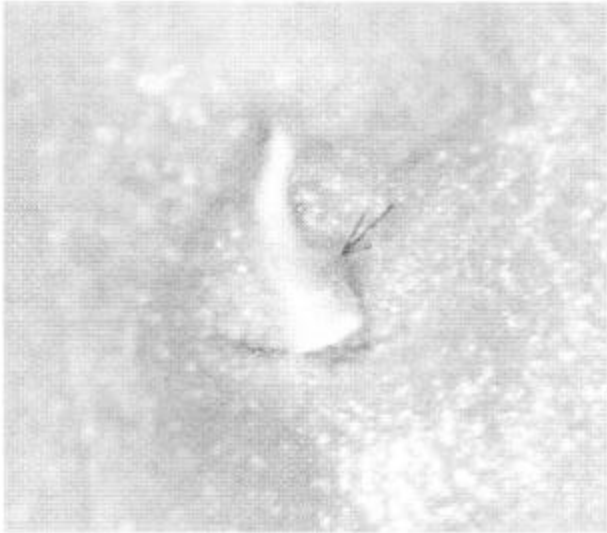
4.2 Contamination from processing or other sources – A nylon contaminant (fig. 3) in an electrical cable was identified by infrared spectroscopy and the particular nylon by its melting point by differential scanning calorimetry (DSC). An acrylic polymer was identified as a contaminant in another instance.

**Figure 3. Nylon contaminant in an electrical cable.  
100X**

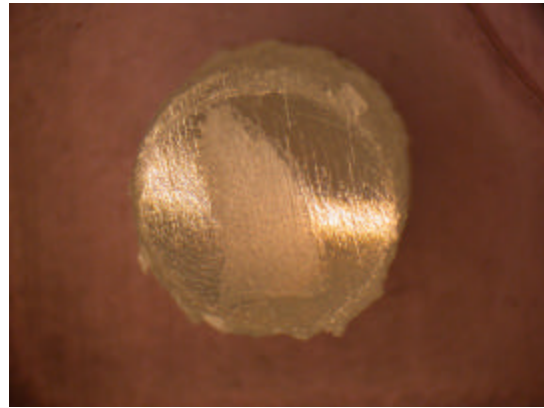
4.3 A stain on a clear plastic (fig. 4) was identified by thermal desorption gas chromatography/mass spectroscopy (TD/GC/MS) as due to unintentional contact with solvent. The compounds found in the stain were not present outside the stain area.

**Figure 4. Stain on clear plastic due to solvent.**
