# FAILURE ANALYSIS OF RUBBER PROTECTIVE GLOVES

*F. Leek\*<sup>1</sup>, G.Lavigne<sup>1</sup>, L.Pinatti<sup>1</sup>, R.Ristau<sup>1</sup> and R.Raymond<sup>2</sup>*  
*<sup>1</sup>Institute of Materials Science, University of Connecticut, Storrs, CT*  
*<sup>2</sup>Northeast Utilities Service Company, Hartford, CT*

## Abstract

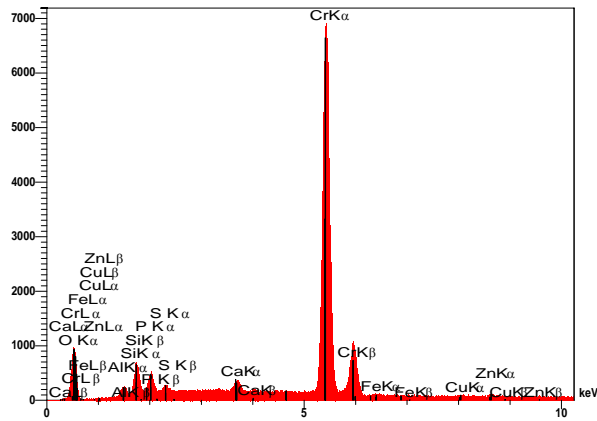
A variety of analytical testing was performed to characterize the leather protective glove from the current supplier. Thermal Gravimetric Analysis (TGA) shows a 8-12% low temperature mass loss which results from loss of water. Single step decomposition is visible above 300°C. Results show ~5% inorganic residue after switching from nitrogen to oxygen purge at 800°C. Energy Dispersive X-ray Spectroscopy (EDX) shows this residue is primarily chromium (~85%) with small amounts (~5%) of silicon and phosphorous (Figure 1). The presence of chromium suggests the leather underwent chromium tanning. Tanning reportedly creates "cross-links" between proteins thus strengthening the final product.

**Figure 1:** EDX of inorganic residue after above TGA.

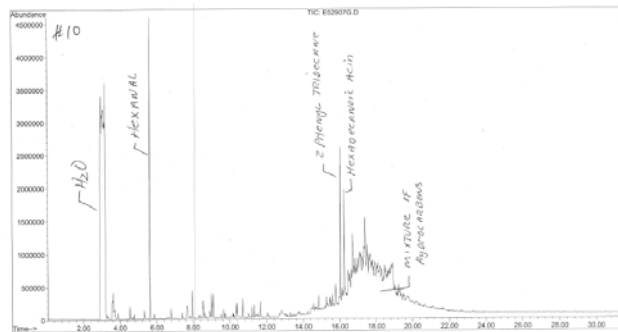
One initial hypothesis suggested that the observed damage may result from incompatibility between rubber and additives, conditioners and oils in the leather gloves. Thermal desorption Gas Chromatography Mass Spectroscopy (TD-GC/MS) was used to characterize low molecular weight volatiles in the leather (Figure 2). The following compounds were prevalent: 2-phenyl tridecane, hexadecanoic acid, hydrocarbon mixture, water and morpholine. Hexadecanoic acid is present in some animal fats and thus may be intrinsic to the hide. The hydrocarbon mixture may reflect the presence of leather conditioners. Morpholine is reportedly a component in leather polish and an antimicrobial agent for leather. None of the compounds identified raised a red flag.

**Figure 2:** TD-GC/MS of new leather glove from the current supplier (200°C, 2 min delay).

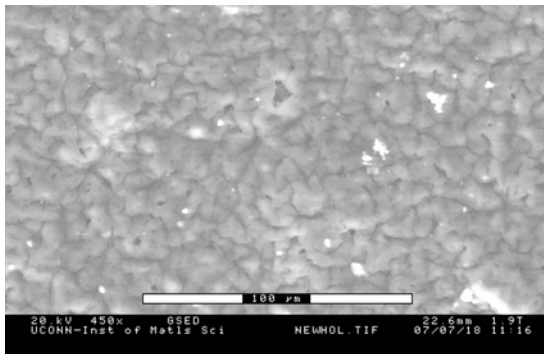
Scanning Electron Microscopy images shows the undamaged surface consists of fused particles (Figure 3). The particle size, uniformity and degree of fusion are a reflection of the glove manufacturing process.

**Figure 3:** SEM image of black rubber outer surface, undamaged region.
